PETERSBURG MEDICAL CENTER

FACILITY CONDITION ASSESSMENT

November 2, 2015

Petersburg Medical Center Facility Condition Survey

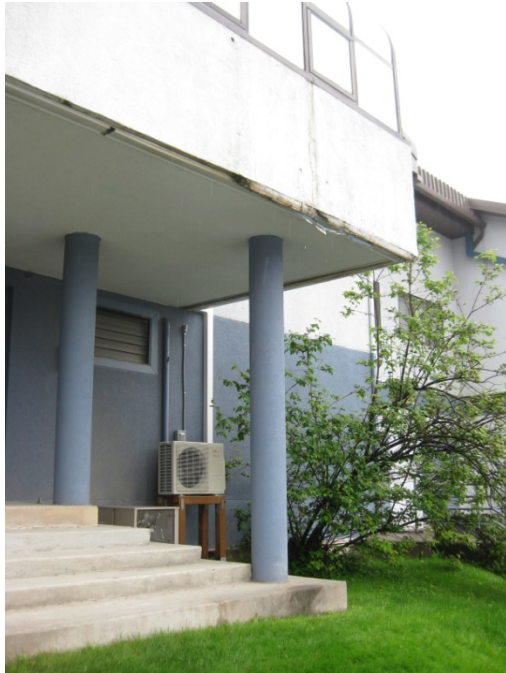
Given its known failures, we do not suggest waiting another 10 -20 years before replacement of the EIFS. Areas that are failing (sun room siding) need to be removed and replaced promptly to prevent further water penetration and damage. The siding has been known to fall off the wall if left un- attended after signs of water penetration appear. This poses a danger to passersby. Photo A1&A2.

A1 Sun Room Siding

We recommend repair of the failing portions in the short term and complete replacement of the cladding with insulated metal siding or installation of metal siding over the existing siding, in the next 5-10 years. Cost for Hospital and LTC: \$330,000. Cost for Clinic: \$41,000

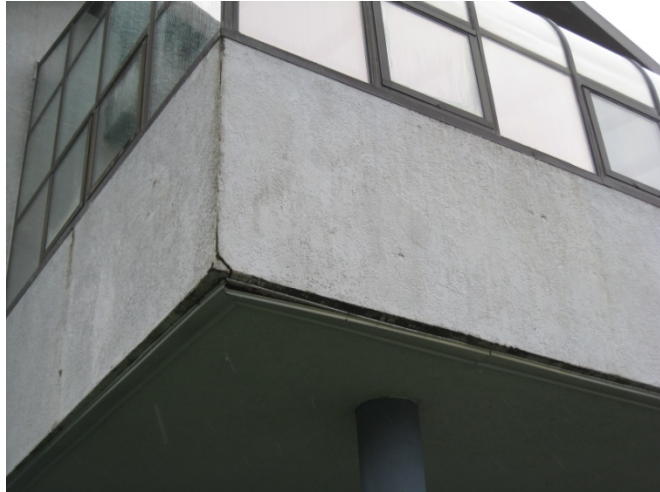
A2 Sun Room Siding

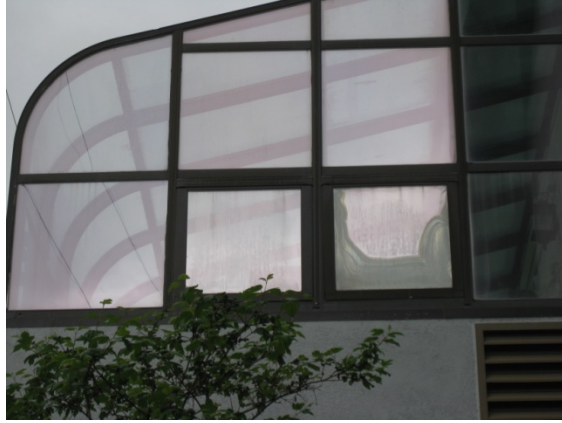
A6 Window Failed Seals

Due to age and improved insulation technology, we recommend replacement of all window units (frames and glass). We recommend insulated windows with a thermal break, fiberglass frames and thermal glazing such as low E glass and argon gas insulation. Cost for Hospital and LTC: \$63,000 Cost for Clinic \$26,000.

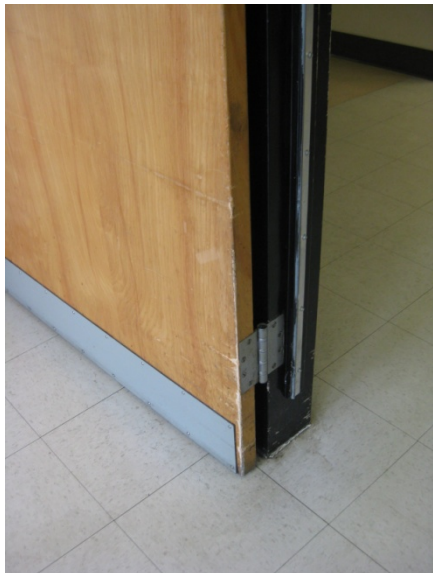
Interior doors in the public and patient care areas are wood doors in hollow metal frames. Doors in service areas are hollow metal in hollow metal frames. High use doors have been damaged at the leading edge of the door and where door hardware has been installed and removed, doors are marred and damaged. Photo A9 & A10.

A9 Interior doors

Replace damaged doors frames and hardware. Cost \$30,000

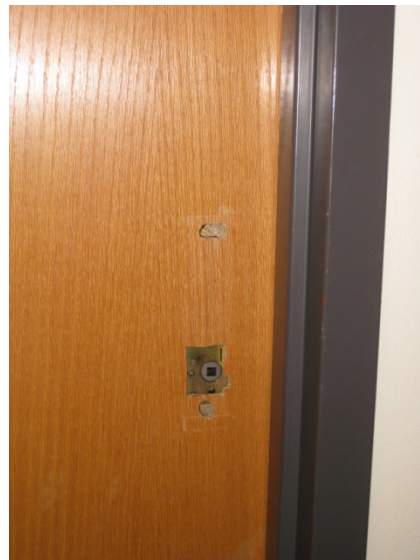
A10 Interior doors

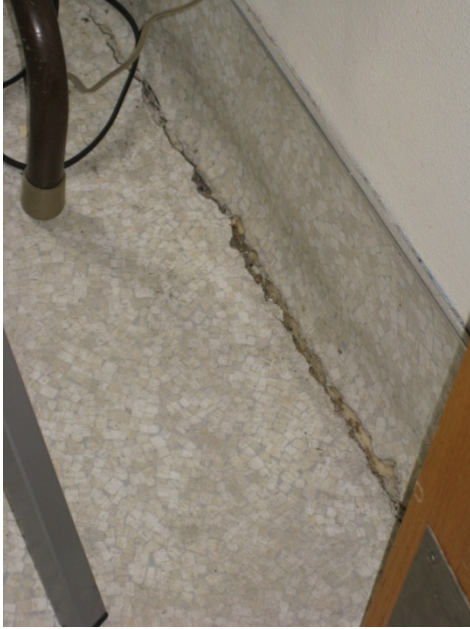
A11 Sheet Vinyl Flooring

Replace flooring throughout the LTC and Hospital. Provide heat welded sheet vinyl in all patient care areas, food service areas and areas requiring sanitation. Water exposure areas such as bathrooms and toilet rooms should either be heat welded sheet vinyl or ceramic tile. Cost: \$340,000

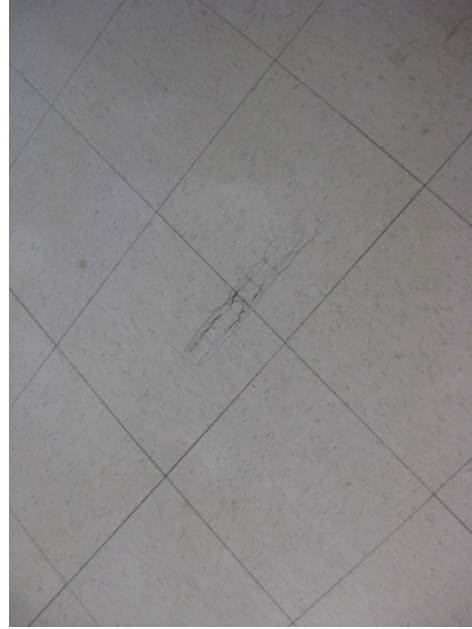
A12 Vinyl Tile

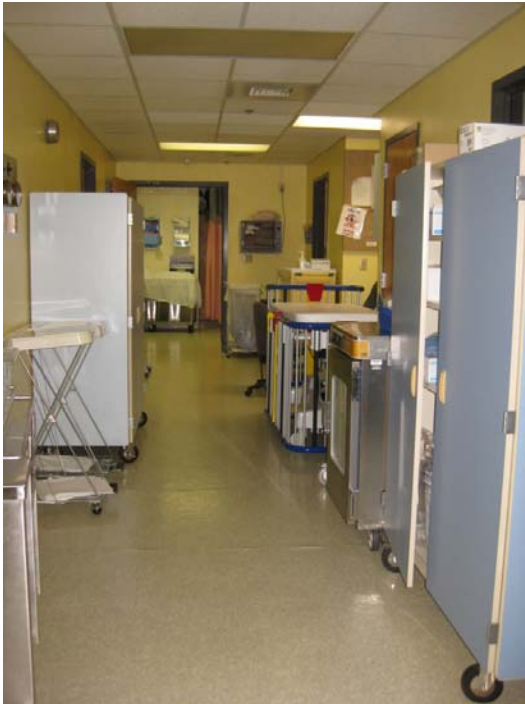
A 13 OR Floor Seams

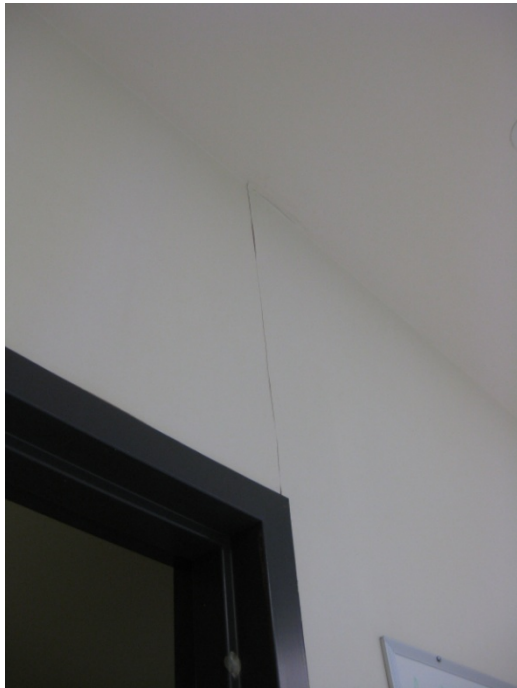
A14 OR wall covering seams

Remove existing vinyl wall covering where it occurs. Install vinyl acrylic wall protection or similar hard scrub-able surface material in patient care areas as prescribed by current guidelines for health care facilities. Additionally a vinyl acrylic wainscot, wall bumper/handrail is recommended in public areas, patient corridors and service halls to protect walls from carts, wheel chairs and stretchers. Cost \$175,000

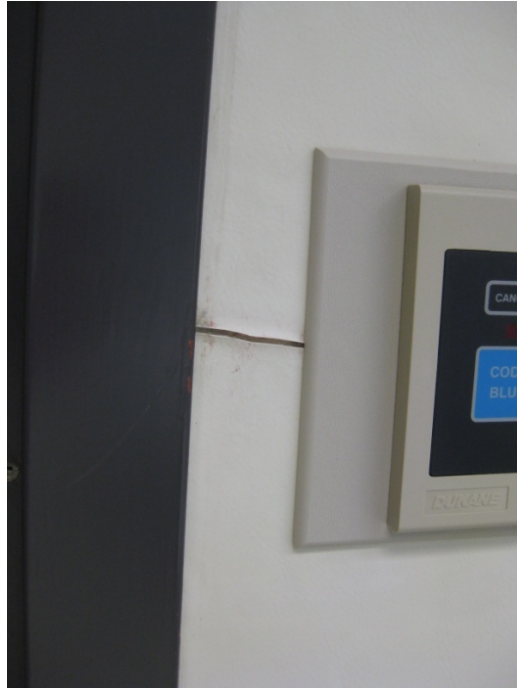
A15 OR wall covering seams

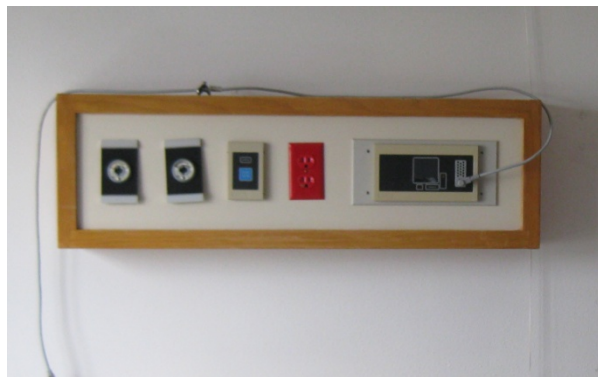
Head walls are provided in patient care spaces where medical gases are supplied. The head wall is custom built of wood trim and plastic laminate face. Cleaning products have worn off the finish on the wood. Health care suppliers such as Hill Rom supply a variety of head wall units designed to serve in various patient care areas. These units provide a variety of attachments and accessories and are fabricated of durable easily cleaned materials that endure cleaning products and do not promote growth of bacteria.

A17 Wood Head Walls

Replace all head wall units with pre manufactured medical head wall units. Cost: \$40,000

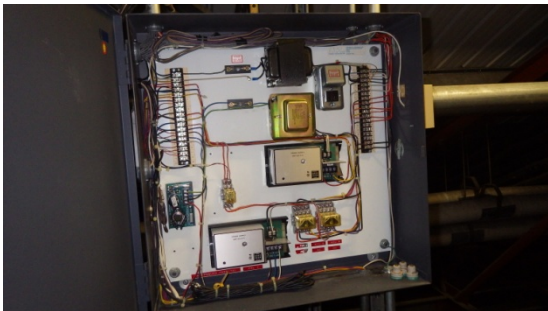
Controls are old and antiquated including the direct digital systems. The existing electronic controls are in poor condition and need replacing. The direct digital controls are of an older version and are not being officially supported anymore. Recommend that the entire facility (Hospital, Long Term Care Facility, and Medical Clinic) get upgraded with modern direct digital controls.

35. LONG TERM CARE FACILITY ATTIC ELECTRONIC CONTROL PANEL

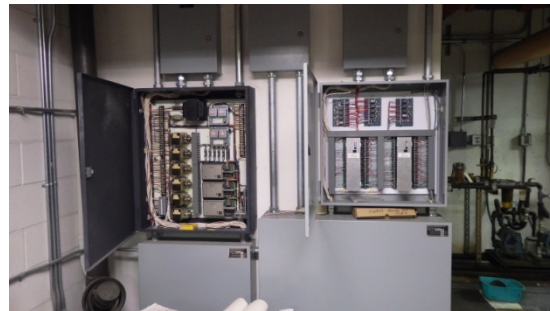
36. HOSPITAL BOILER ROOM MIX OF ELECTRONIC AND DDC CONTROLS
