PETERSBURG MEDICAL CENTER

FACILITY CONDITION ASSESSMENT

November 2, 2015

Petersburg Medical Center Facility Condition Survey

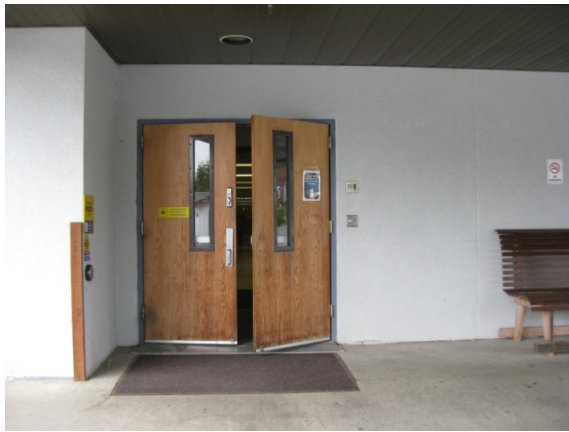
A7 Entry Door at Emergency

Replace all wood exterior doors with insulated hollow metal or aluminum doors. Cost : \$6,000 Replace weather stripping hardware on all doors including thresholds and door sweeps. Cost: \$8,000

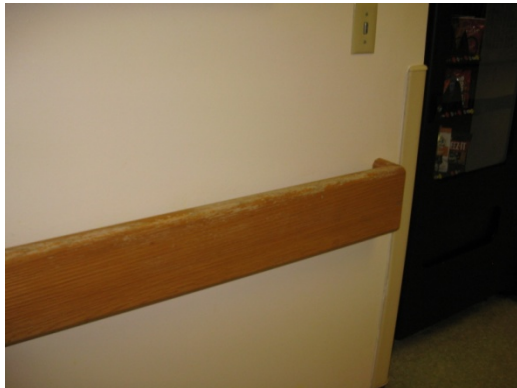
A16 Wood Railings

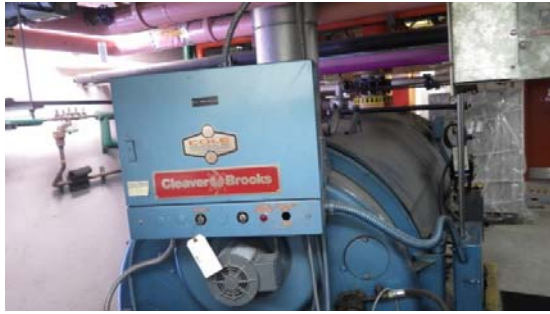
1. HOSPITAL
OIL FIRED BOILER

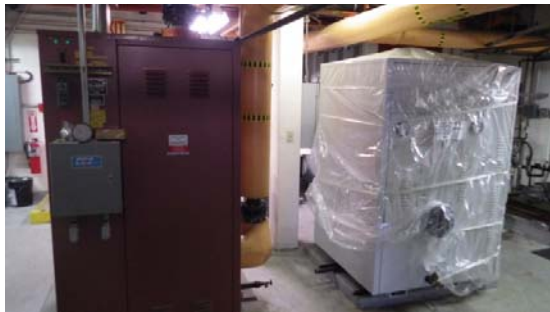
3. HOSPITAL
ELECTRIC BOILERS

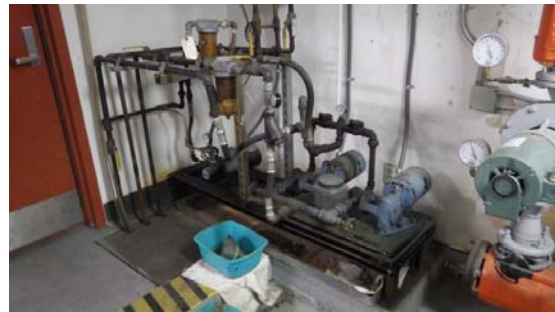
4. HOSPITAL
OIL PUMPS

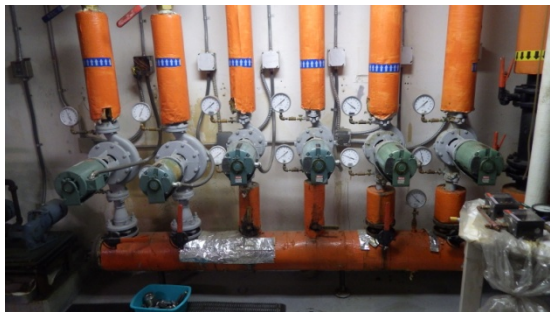
5. HOSPITAL
HEATING PUMPS

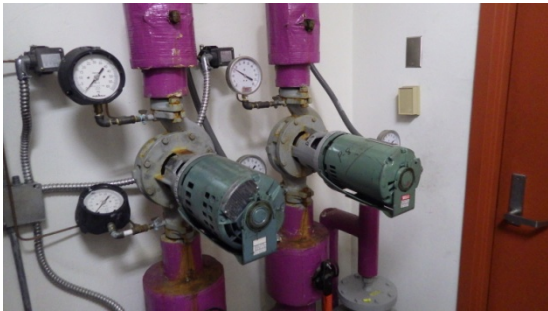
9. HOSPITAL
CHILLED WATER PUMPS

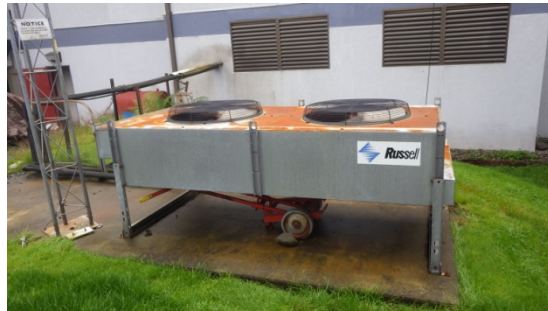
10. HOSPITAL
CHILLER EXTERIOR CONDENSERS

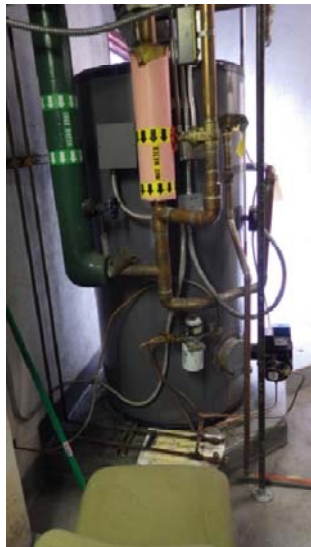
11. HOSPITAL
OIL FIRED HOT WATER HEATER

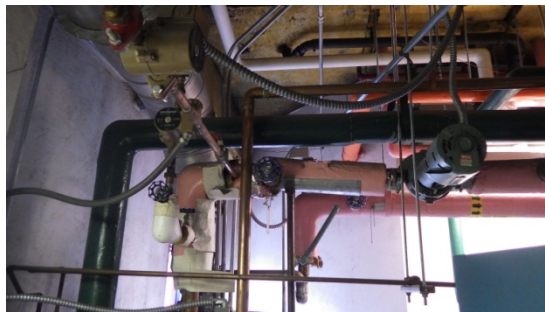
12. HOSPITAL
DOMESTIC HOT WATER
RECIRCULATION PUMPS

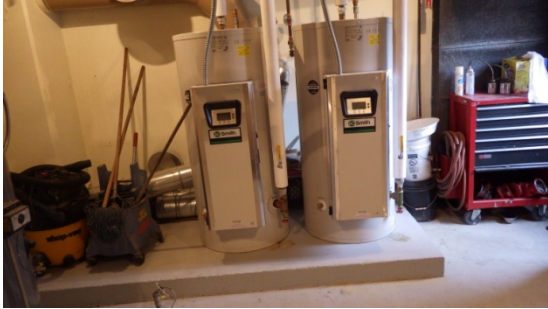
13. LONG TERM CARE FACILITY
ELECTRIC HOT WATER TANKS

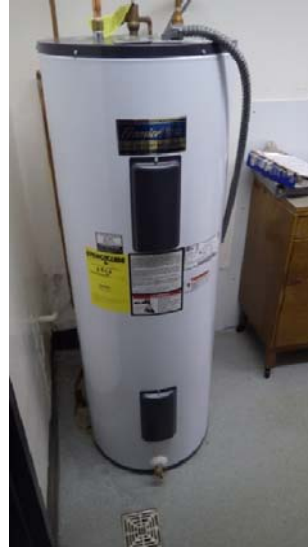
14. HOSPITAL KITCHEN
HOT WATER TANK

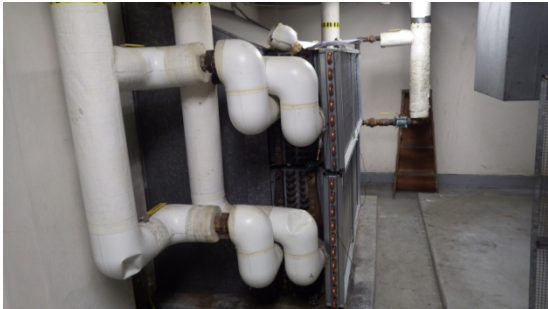
15. HOSPITAL FAN ROOM
INTAKE PLENUM WITH HEAT
RECOVERY COIL

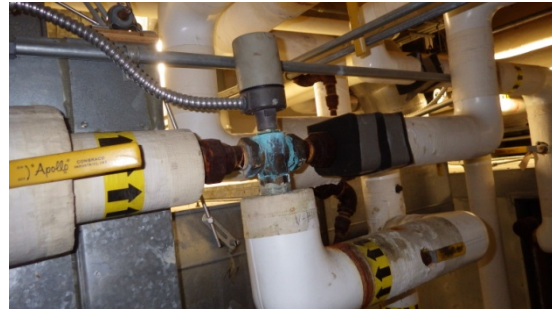
16. HOSPITAL FAN ROOM
HEAT RECOVERY PIPING,
AHU BEYOND

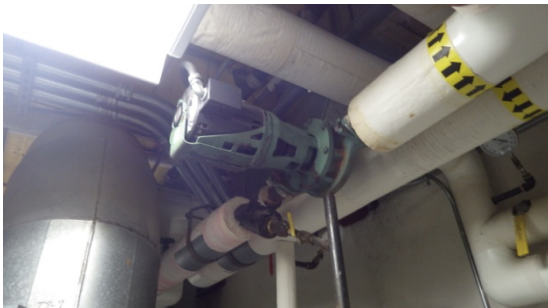
17. HOSPITAL FAN ROOM
HEAT RECOVERY PUMP

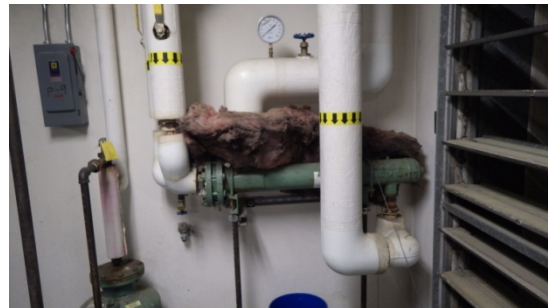
18. HOSPITAL FAN ROOM HEAT
RECOVERY HEAT EXCHANGER

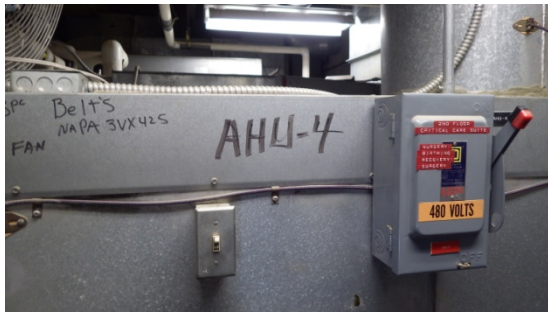
19. HOSPITAL FAN ROOM AHU-4 AIR HANDLING UNIT

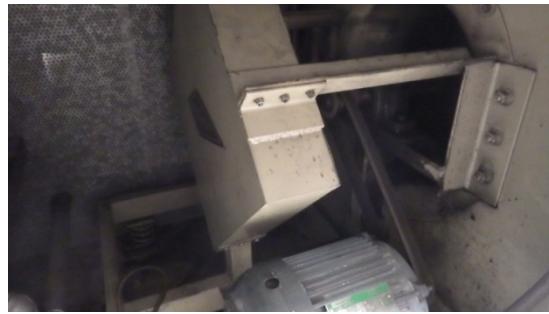
20. HOSPITAL FAN ROOM AHU-4 SUPPLY FAN

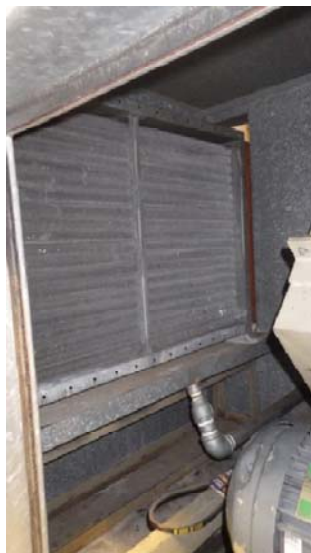
21. HOSPITAL FAN ROOM AIR HANDLING UNIT AHU-4 HEATING COIL

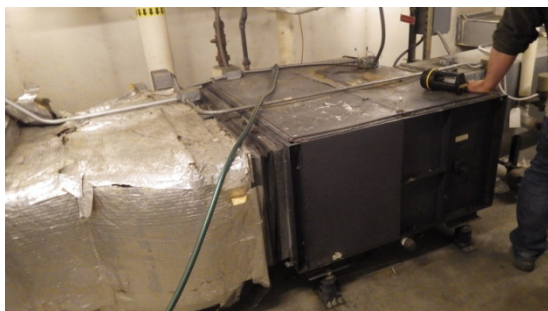
23. LONG TERM CARE FACILITY ATTIC AHU-5

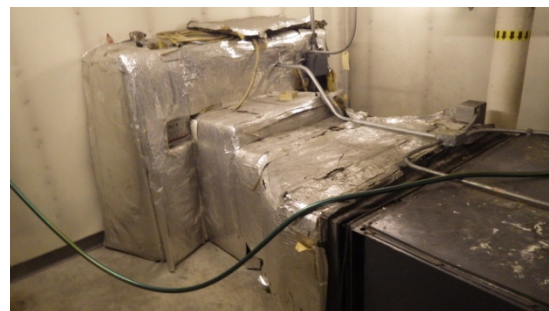
24. LONG TERM CARE FACILITY ATTIC AHU-5 INTAKE PLENUM

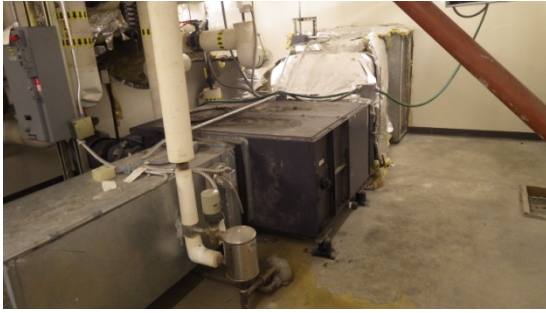
25. LONG TERM CARE FACILITY
ATTIC AHU-6

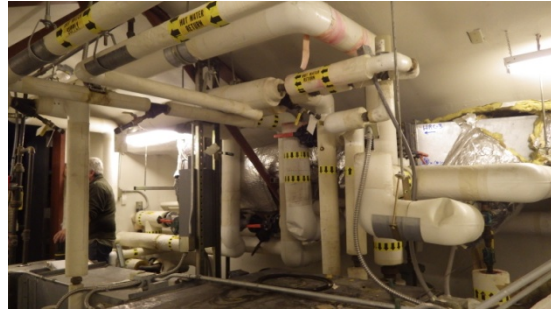
26. LONG TERM CARE FACILITY
ATTIC AHU-6 PIPING

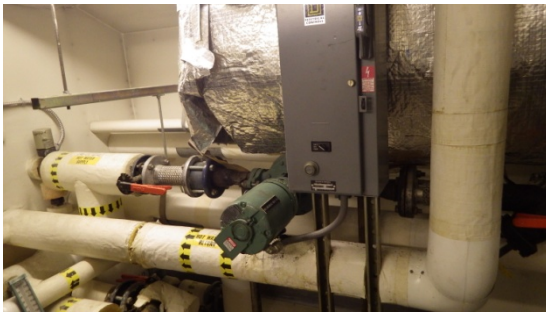
27. LONG TERM CARE FACILITY ATTIC
AHU-5 & 6 HEAT RECOVERY
PUMP

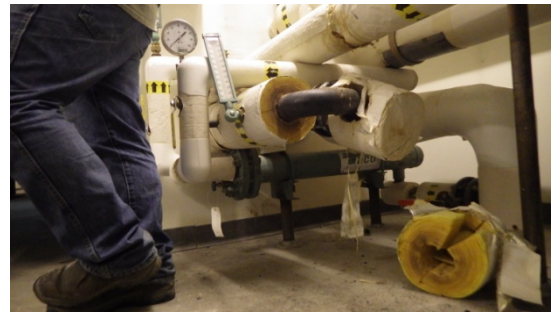
28. LONG TERM CARE FACILITY ATTIC
AHU-5 & 6 HEAT EXCHANGER

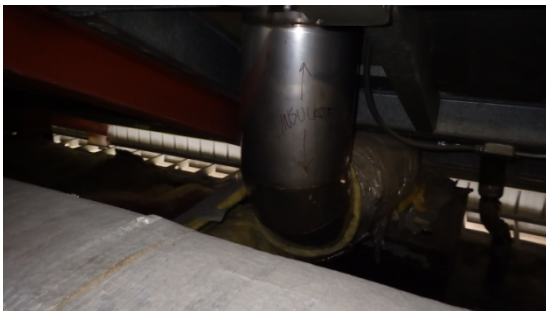
29. LONG TERM CARE FACILITY ATTIC
KITCHEN GREASE EXHAUST DUCT

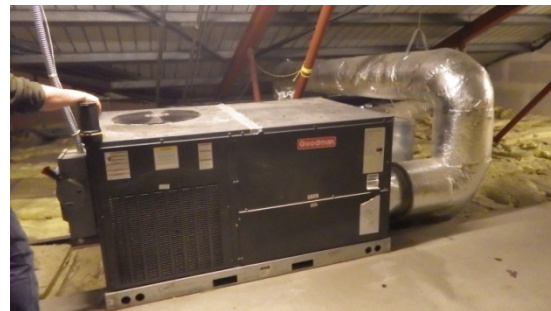
30. HOSPITAL LAB CT ROOM
HEAT PUMP AIR-CONDITIONING
RECIRCULATION FAN

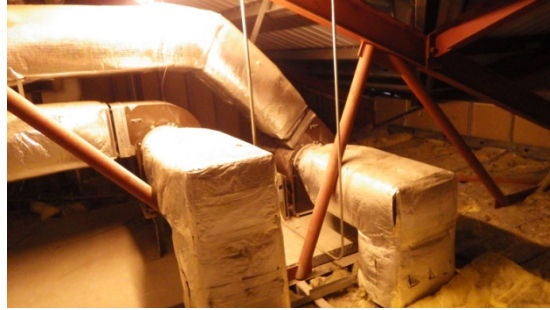
32. HOSPITAL ATTIC TYPICAL EXHAUST FAN

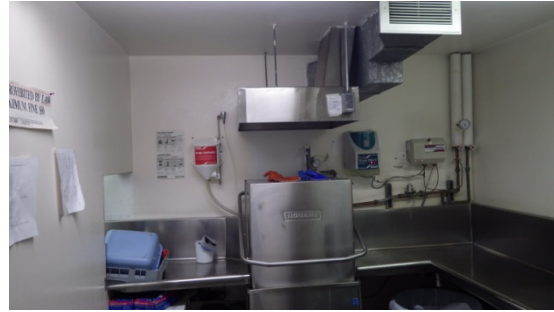
38. KITCHEN DISHWASHING ROOM

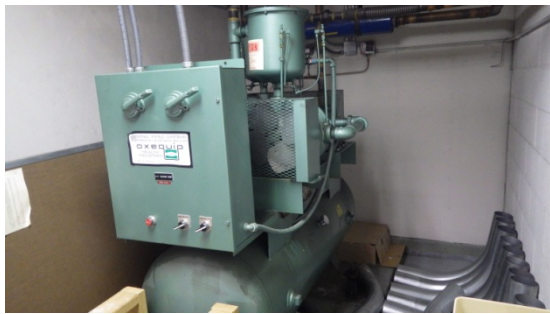
39. HOSPITAL BOILER ROOM
VACUUM PUMP

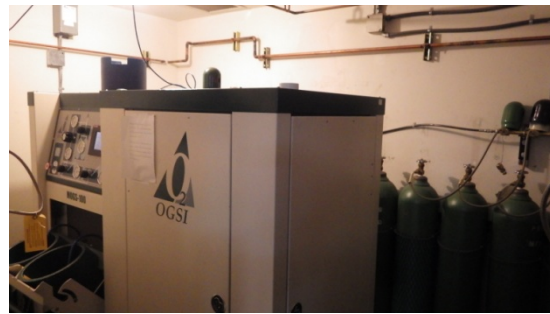
40. HOSPITAL MEDICAL GAS ROOM
MEDICAL AIR COMPRESSOR

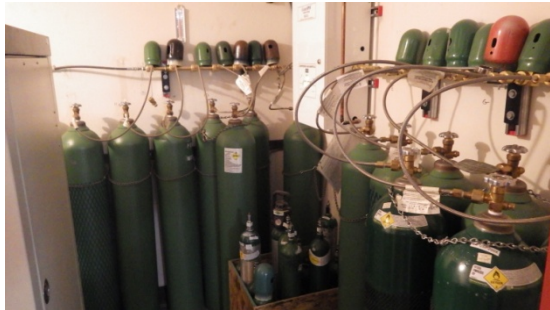
41. HOSPITAL MEDICAL GAS ROOM

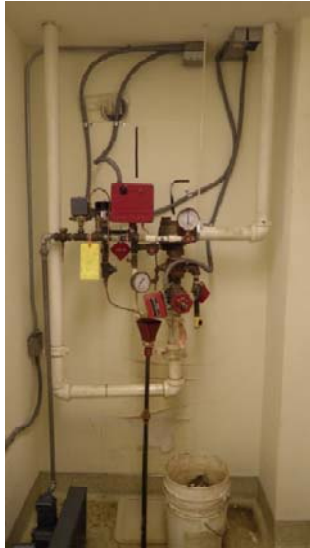
43. HOSPITAL SATELLITE DRY SPRINKLER
HEADER

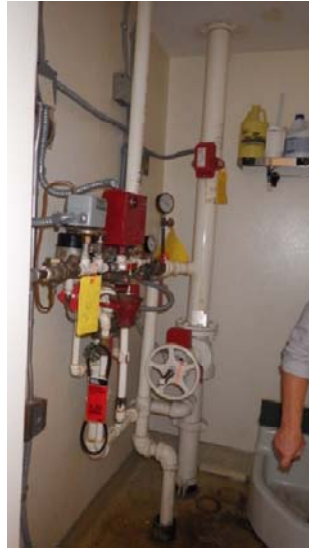
44. HOSPITAL SATELLITE DRY SPRINKLER
HEADER

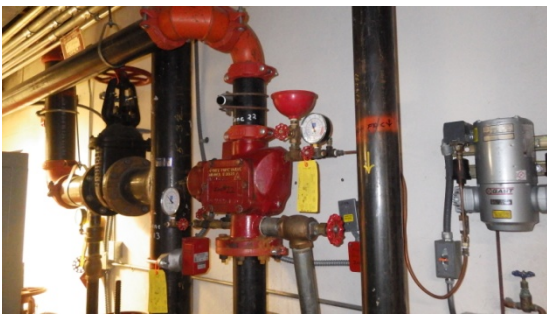
45. HOSPITAL SPRINKLER HEADER

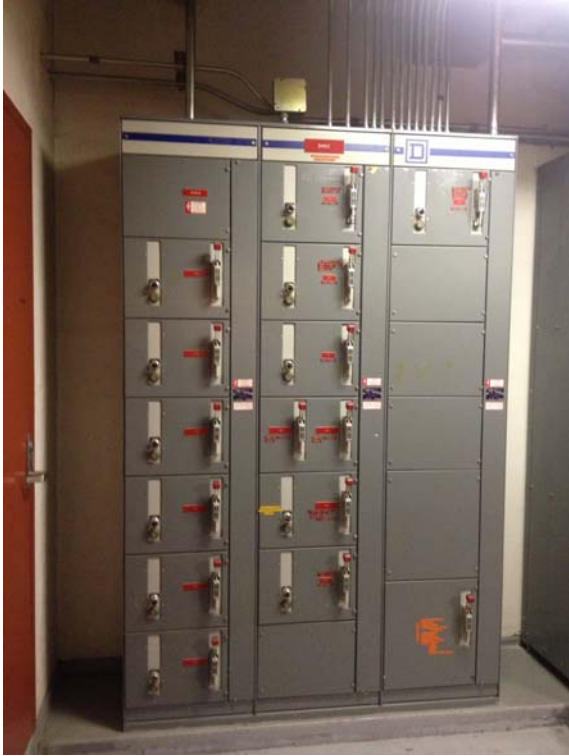
There is one large motor control center for the facility, located in the hospital, which provides power to the air handling units, pumps, and other miscellaneous equipment in Mechanical Rooms 170 and 170A (see photo 3). The limited equipment located outside of the mechanical rooms and in the clinic is equipped with independent combination starters.

Photo 2: Motor Control Center

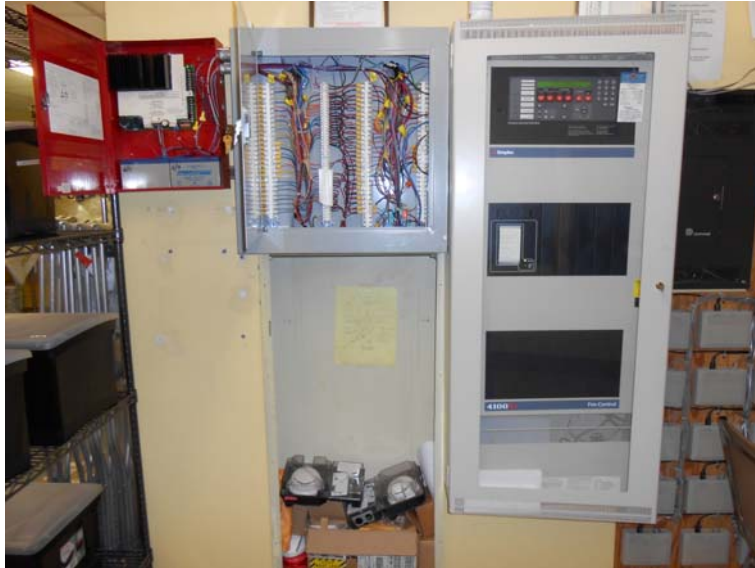
The main fire alarm control panel is a microprocessor-based, addressable unit (see photo 6). It is located in General Storage 128 (see photo 6). The initiating and indicating devices are analog style, connected through zone modules for monitoring by the fire alarm control panel. A booster power supply provides power to indicating circuits. Initiating devices consist of smoke detectors in the corridors and patient rooms, heat detectors in the mechanical and utility spaces, and manual pull stations at exterior exits and exits from the second floor. Bells are utilized for occupant notification.

Photo 6: Fire Alarm Control Panel and Accessories

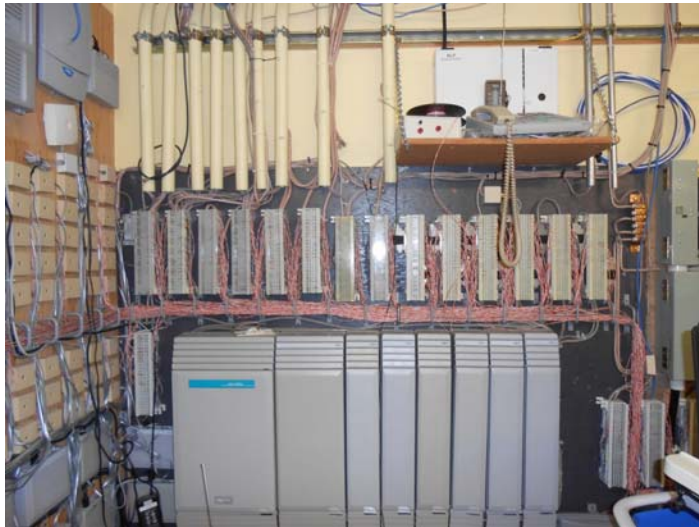
The outside plant telephone and optical fiber cables terminate at a communications backboard in General Storage 128. The communications backboard contains service entrance terminations, 110-blocks, a telephone switch, and intercom equipment and terminations (see photo 7). A secondary communications backboard is located in Storage Room 242. Most of the network equipment is located in Files 142 (see photo 8). Small network racks are located in Storage Room 242 and Histo 331. The telephone system wiring is Category 3 vintage, or older. The network cables are mostly Category 5. Many of the cables are routed unsupported in the accessible ceilings.

Photo 7: Telephone Switch and System Interconnections

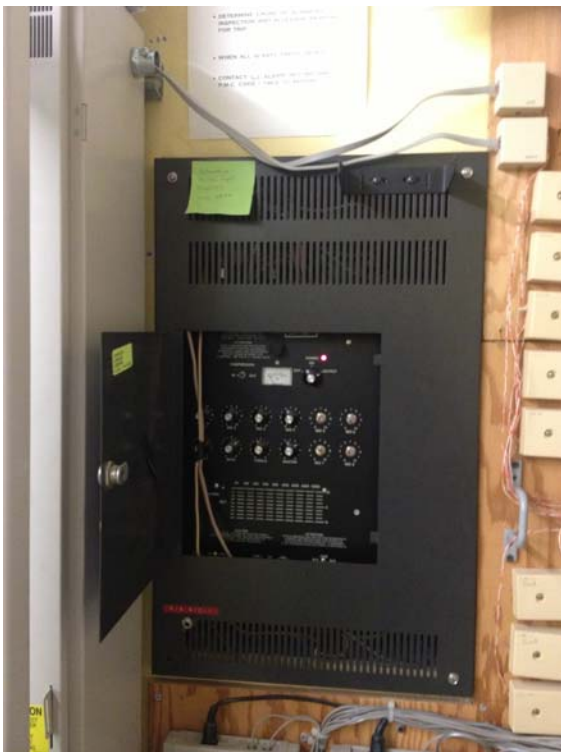
The intercom system amplifier is located on the communication backboard in General Storage 128 (see photo 9). The system is connected to corridor speakers and the telephone system speakers. Pages are accomplished with telephone handsets.

Photo 9: Intercom System Amplifier
