PETERSBURG MEDICAL CENTER

FACILITY CONDITION ASSESSMENT

November 2, 2015

Petersburg Medical Center Facility Condition Survey

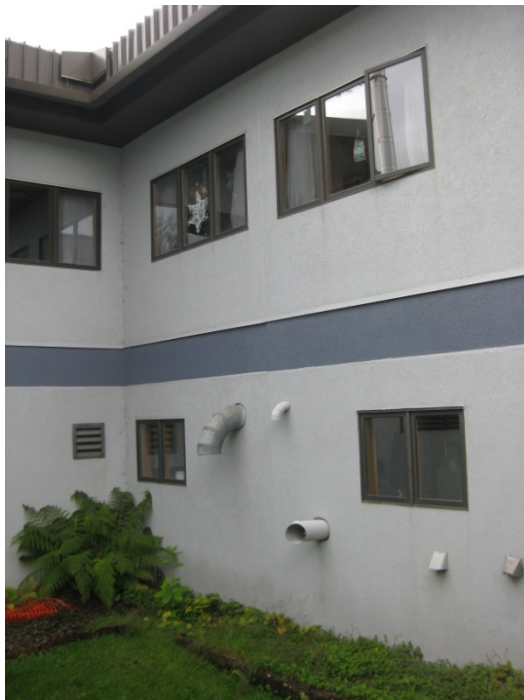
A3 Windows 1984

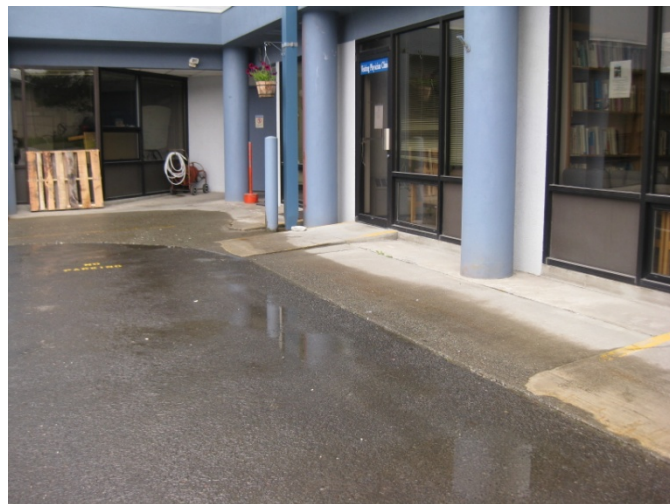
A4 Windows Infill

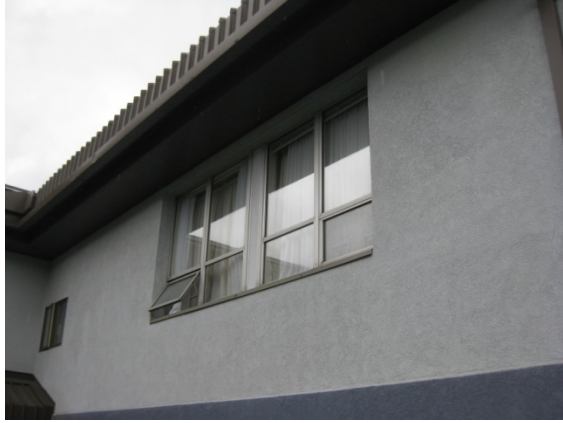
A5 Windows LTC

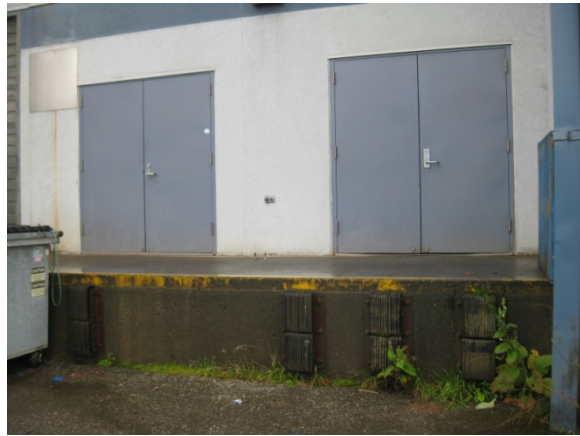
A8 Service Doors

Replace all wood exterior doors with insulated hollow metal or aluminum doors. Cost : \$6,000 Replace weather stripping hardware on all doors including thresholds and door sweeps. Cost: \$8,000

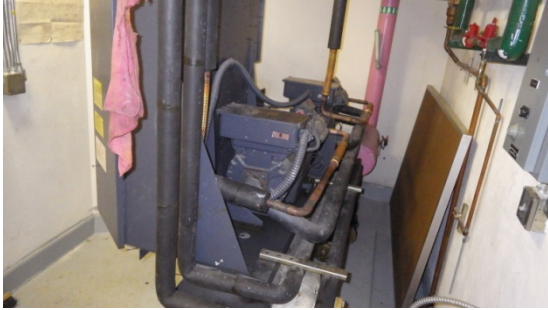
7. HOSPITAL
CHILLER

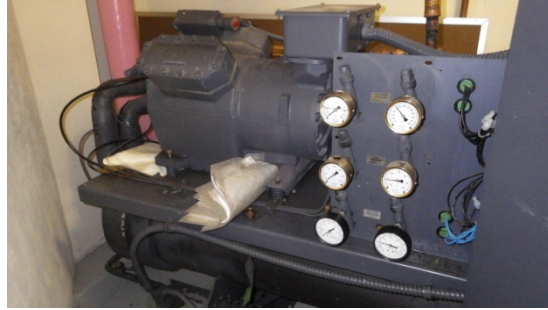
8. HOSPITAL
CHILLER

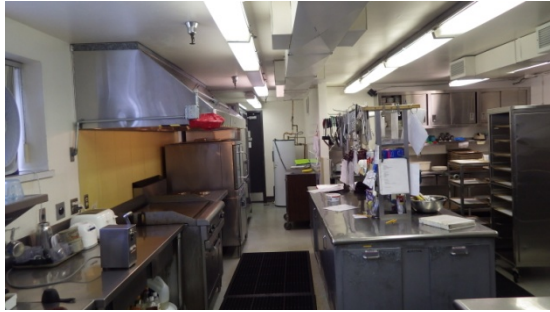
37. KITCHEN TYPE 1 HOOD ON LEFT

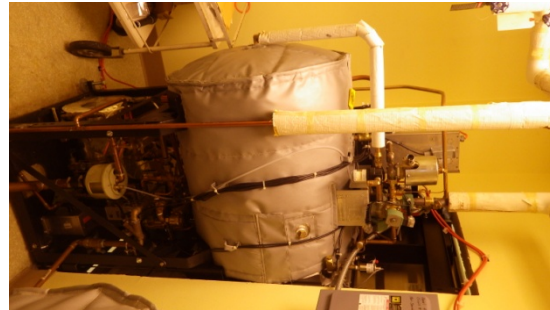
42. HOSPITAL STERILIZER

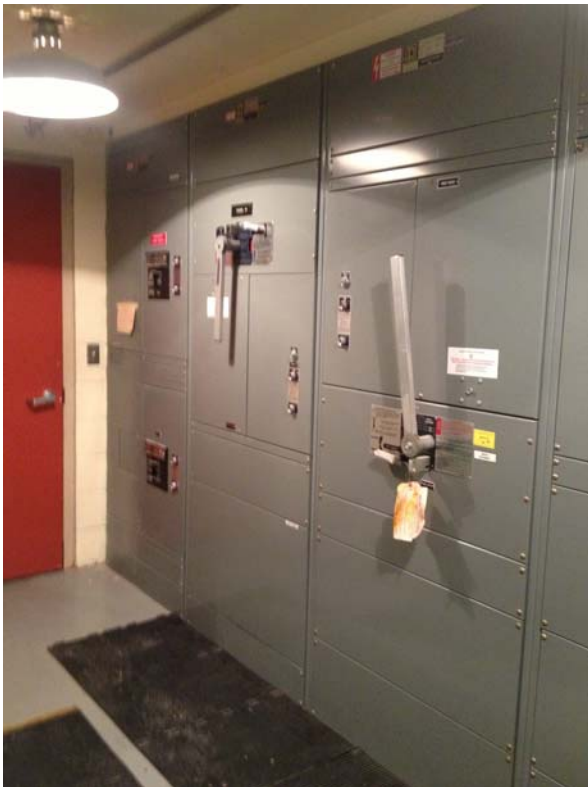
Electrical 105 is the main electrical room for the facility and houses most of the service distribution equipment. Service feeders from an exterior pad mounted transformer terminate at a Main Switchboard with a 2000 amp, 480 volt, 3-phase main bolted pressure switch. The Main Switchboard provides overcurrent protection for three sub-feeders (see photo 1). A 400 amp, 3-pole circuit breaker feeds the emergency distribution system through a transfer switch. The alternate source of power is a 250kW diesel generator located in Generator 104. The transfer switch feeds distribution, lighting, and appliance panelboards throughout the facility that serve equipment, life safety, and critical loads. A second 400 amp, 3-pole circuit breaker feeds Panelboard DH. Panelboard DH provides normal power to lighting and appliance panelboards throughout the facility (see photo 2). The third overcurrent protection device is a 1600 amp, 3-pole bolted pressure switch that feeds Distribution Panel M in Mechanical 107A. Distribution Panel M feeds the electric boiler and other ancillary mechanical loads in Mechanical 107A. All of the overcurrent protection devices are equipped with ground fault detection.

Photo 1: Main Switchboard

Recommendation: Demolish the Hospital and Long Term Care Wing power distribution system. Provide a new system that includes service entrance equipment, emergency generator, transfer switches, distribution boards, panelboards, and associated feeders.
